Jefferson County

HIGH HAZARD LOCATION STUDY

Robert Peccia &
Associates

December 1982

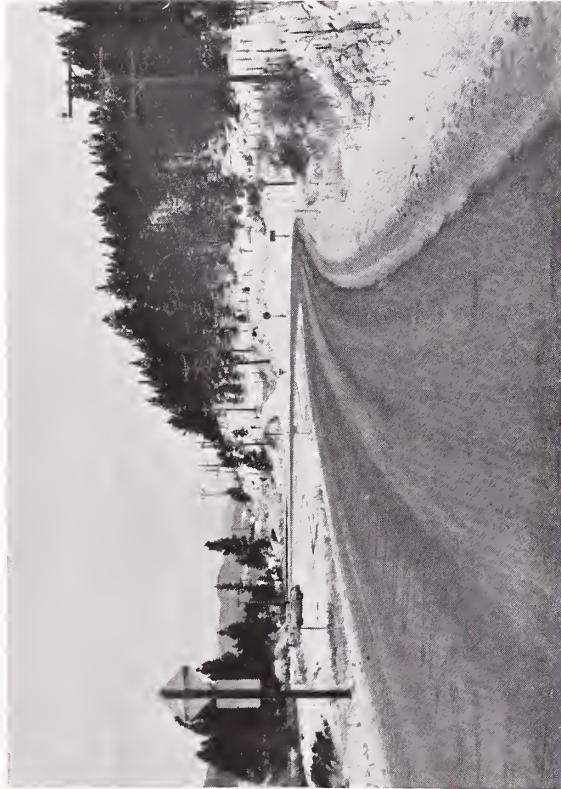
View of signing, striping, and delineation in the curve on the north approach at Site 1.

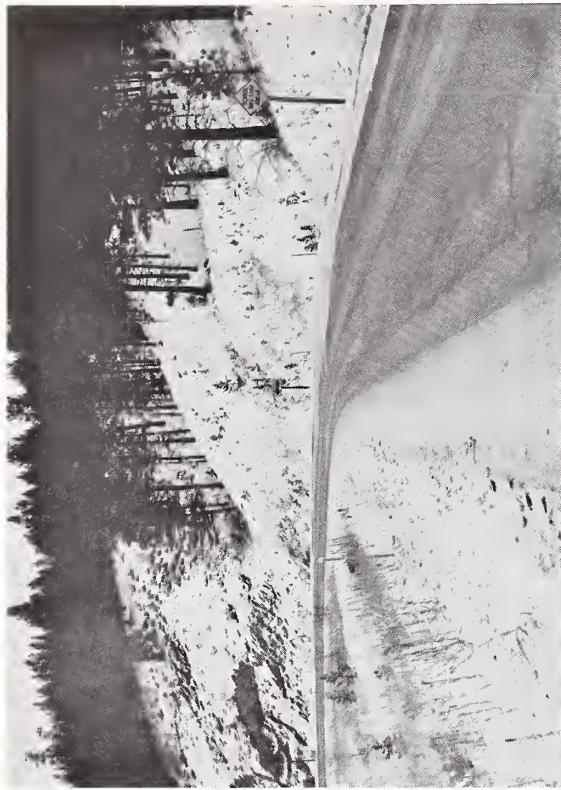
View of the signing, striping, and delineation in the curve on the south approach to the site.

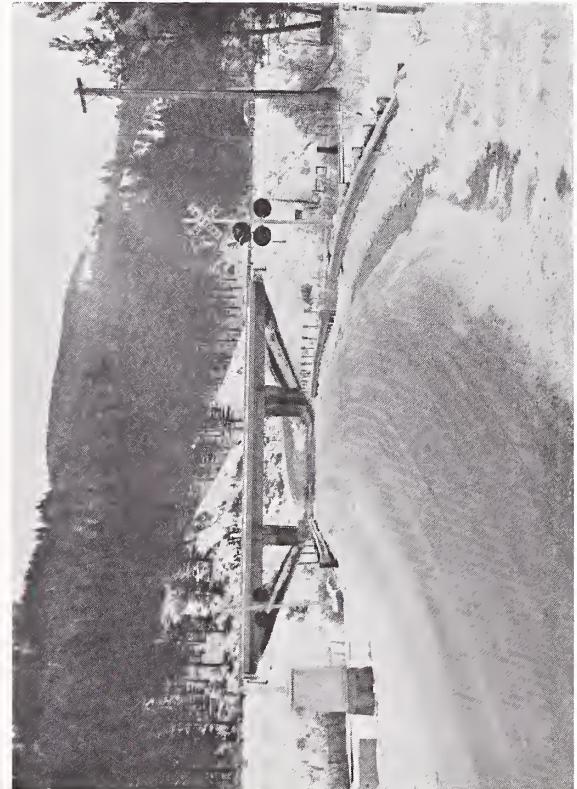
The Frontage Road near the intersection of Blue Sky Heights Road and the Frontage Road. The BNR line at the site has not been used since it was damaged by flooding in 1981.

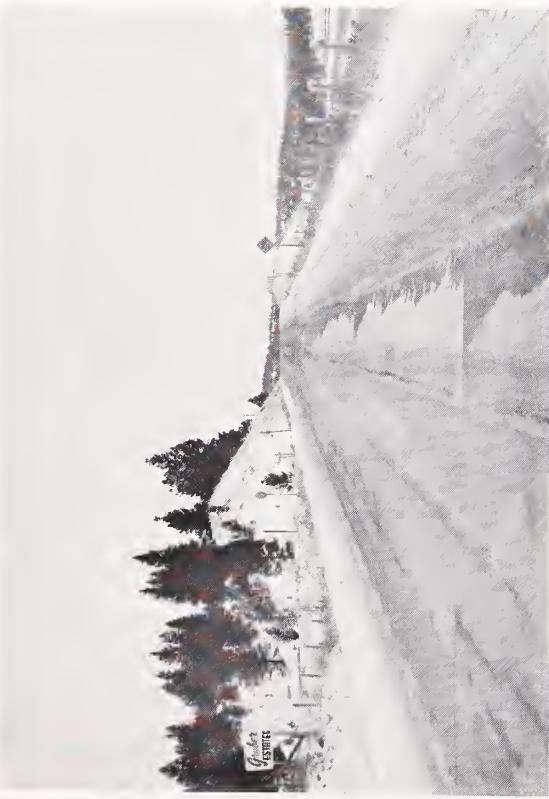
Site 2 as viewed from the north approach. Road grades on the Frontage Road are consistent at 4.3 percent.

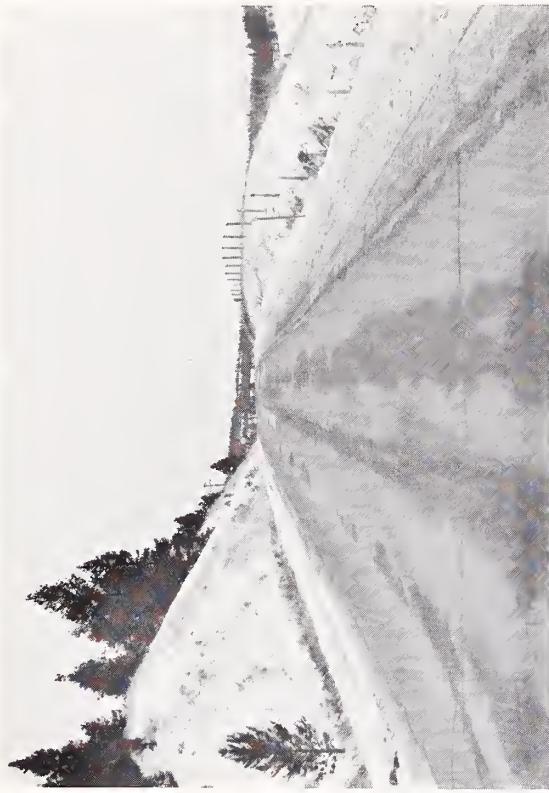
View of the south approach to the site. Note the centerline striping and delineation.

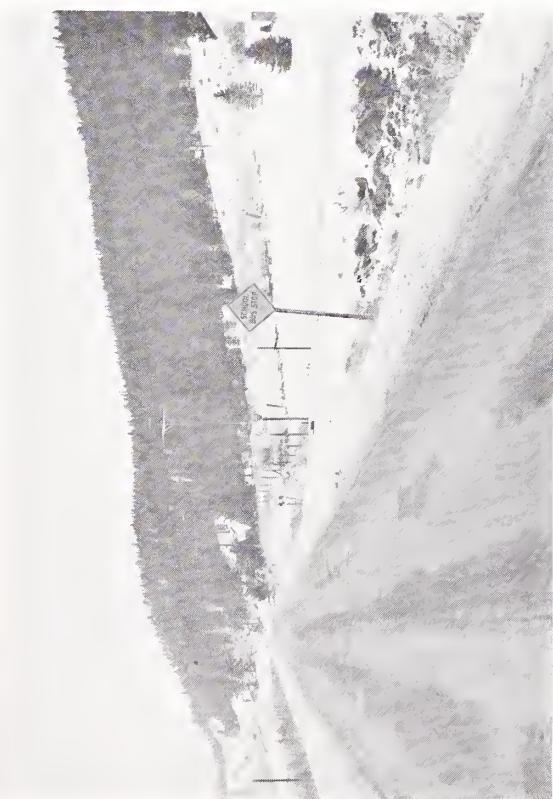
View at the intersection of the Gruber Estates Road and the Frontage Road. Note the steep area adjacent to the roadway.

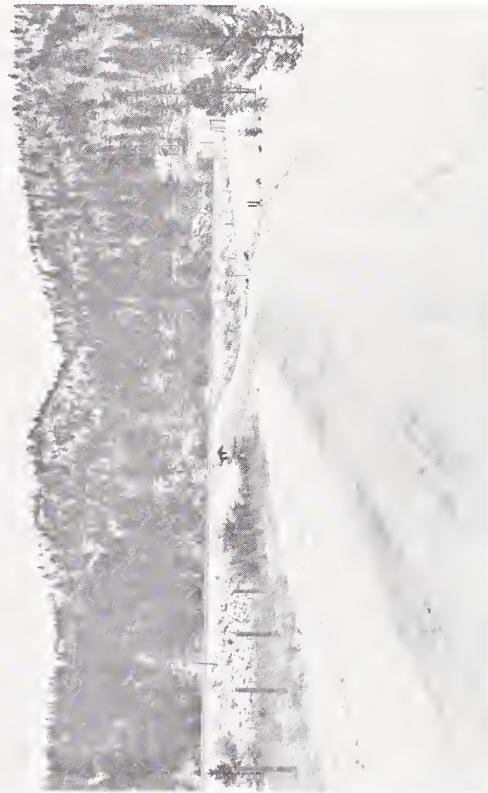
View of the east approach to the intersection. Note the approach grade at the intersection and the steep areas adjacent to the roadway.

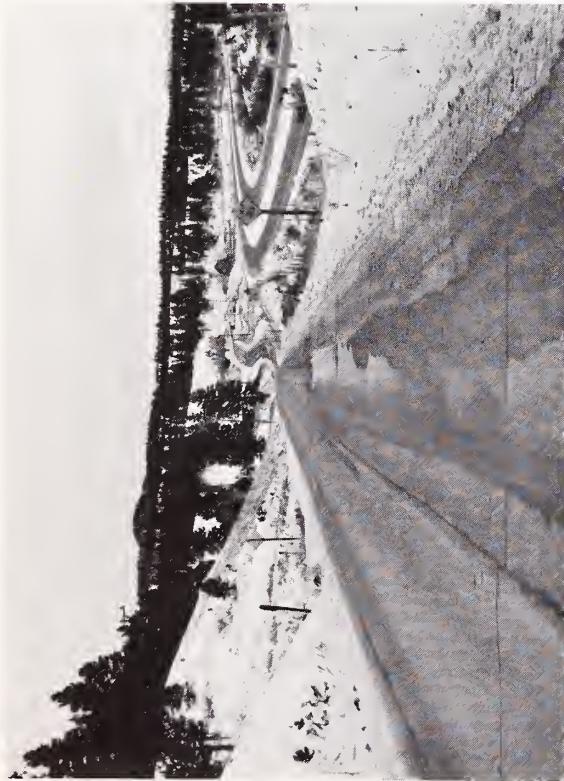
View of the north approach to the intersection. Note the hidden nature of the south Gruber Estates Road at left.

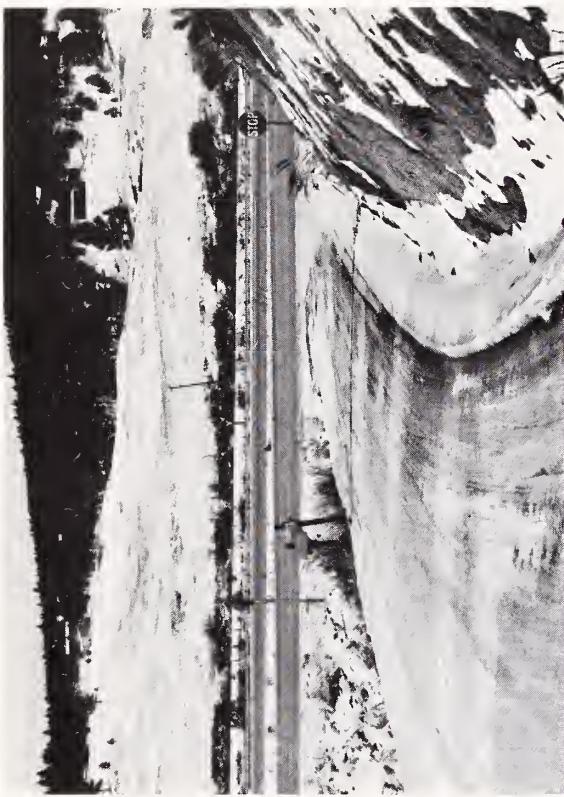
View of the intersection of the I-15 Frontage Road and the south entrance to Gruber Estates.

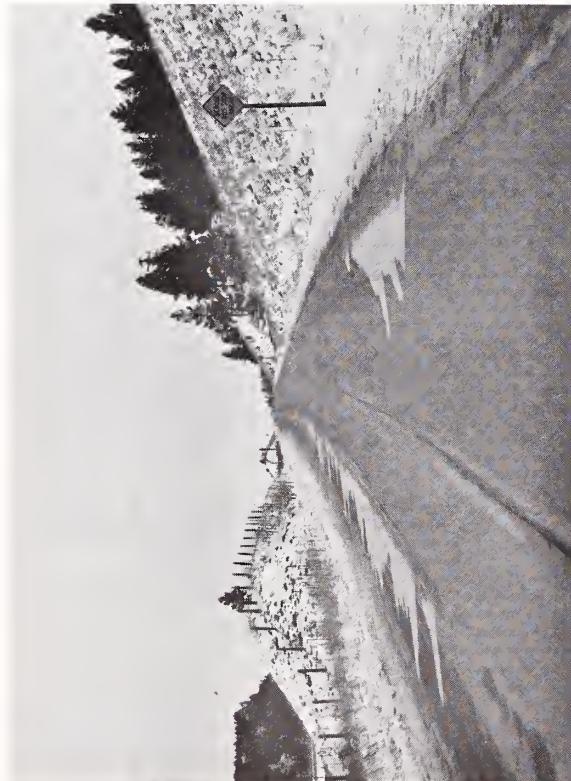
View of the south approach to the intersection. The existing signing and pavement markings are similar on the north approach.

The terrain, alignment change, and 11.4 percent grade allow motorists to see the stop sign only 150 feet in advance of the intersection on the east approach.

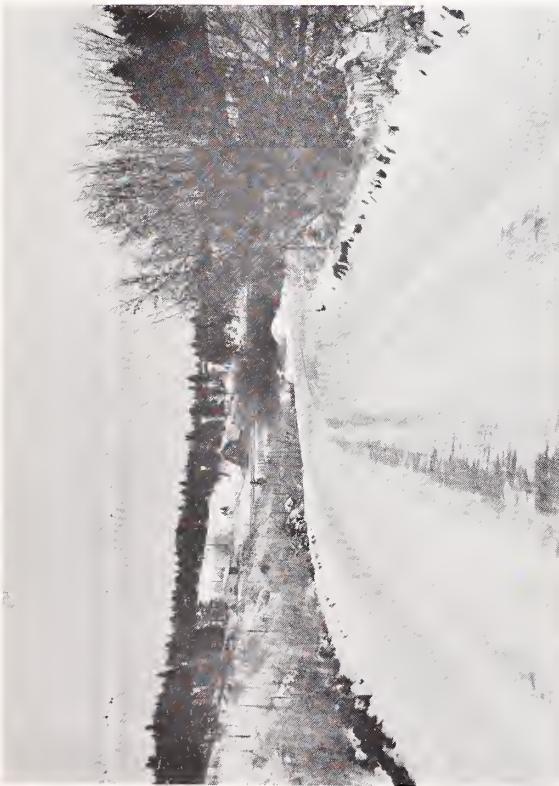
View of the north approach to the Prickly Pear Creek Bridge.
Sight distance on this approach is limited to 210 feet by
roadside vegetation.

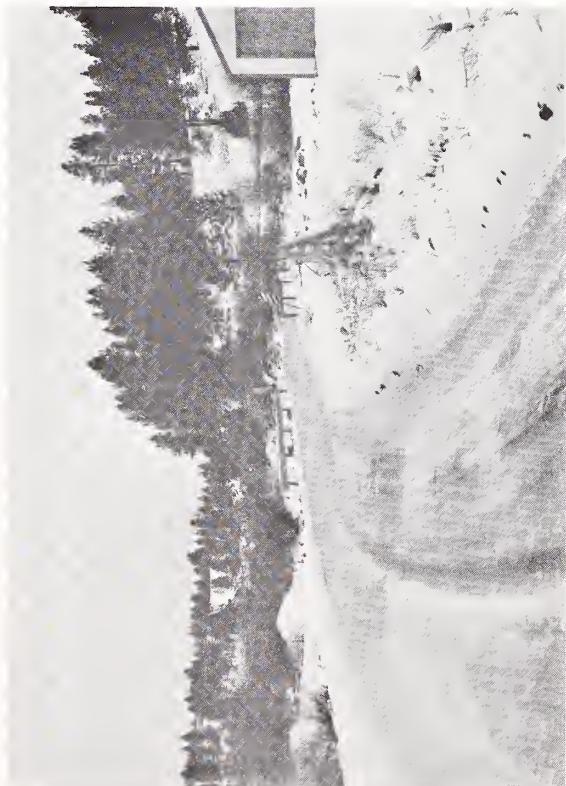
View of change in road alignment at the bridge. Note the lack of a left object marker and the temporary installation of the right object marker.

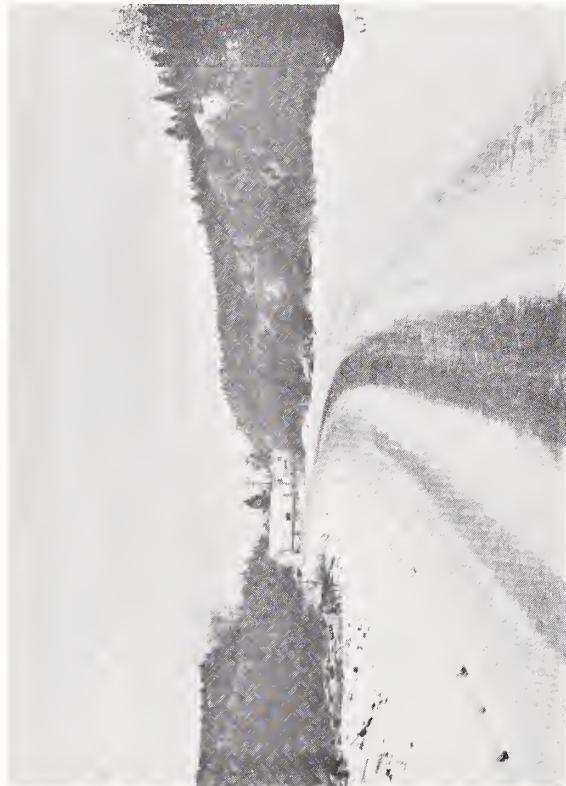
View of south approach to the bridge. Note advance turn warning sign and the area of trimmed back vegetation to the left of the photo.

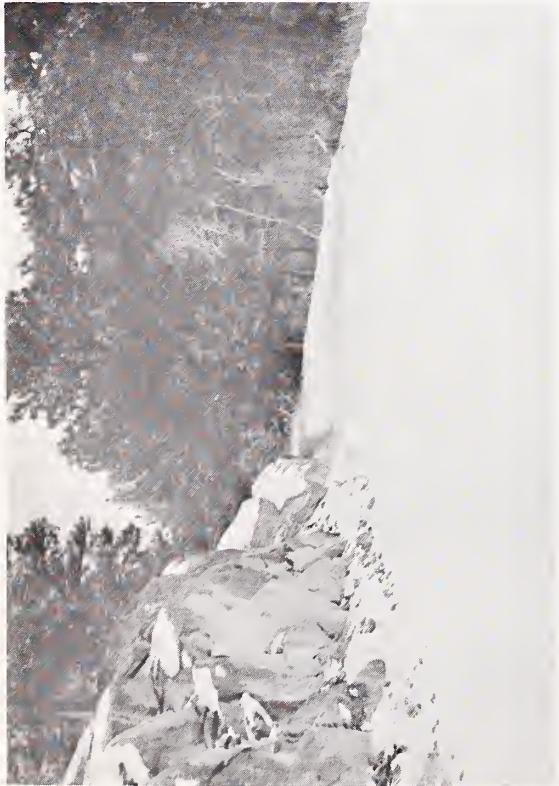
View of the Lump Gulch Road in Site 5. Note the rock outcrop, which limits sight distance.

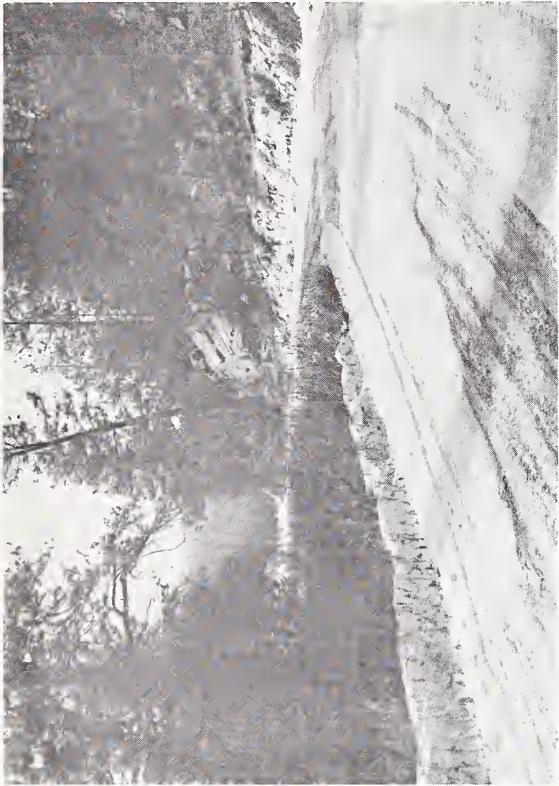
View of the reverse turns in the eastern portion of the site. Note thick roadside vegetation and steep areas adjacent to the roadway in this portion of the site.

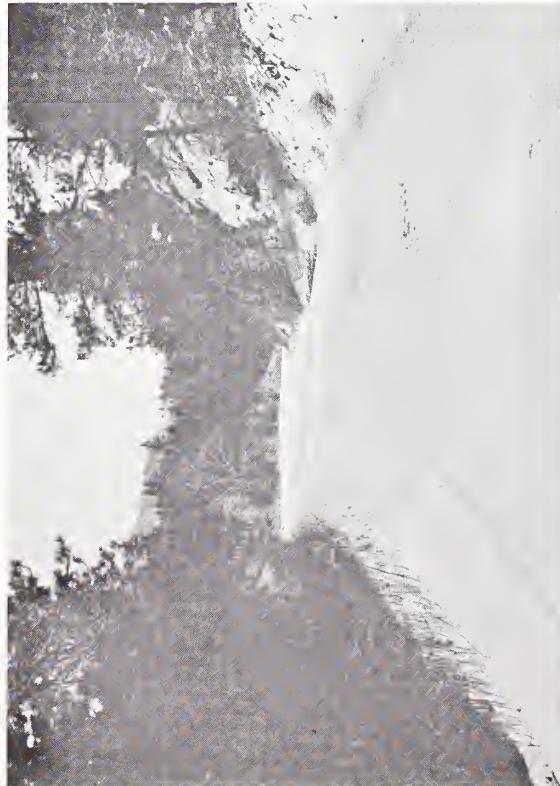
View of roadway in the eastern portion of the site. Note the large rock outcrops limit sight distance at several locations in this site. Sight distance is limited to 120 feet at this location.

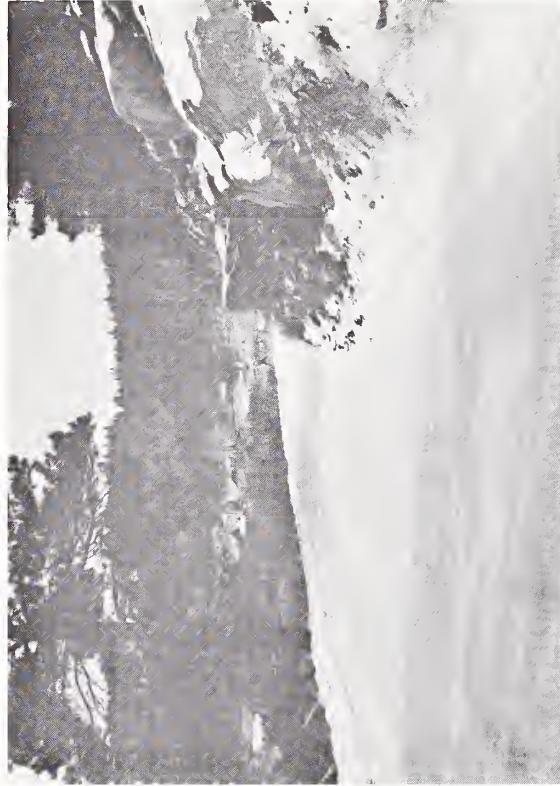
Large rock outcrops limit sight distance at several locations in this site. Sight distance is limited to 120 feet at this location.

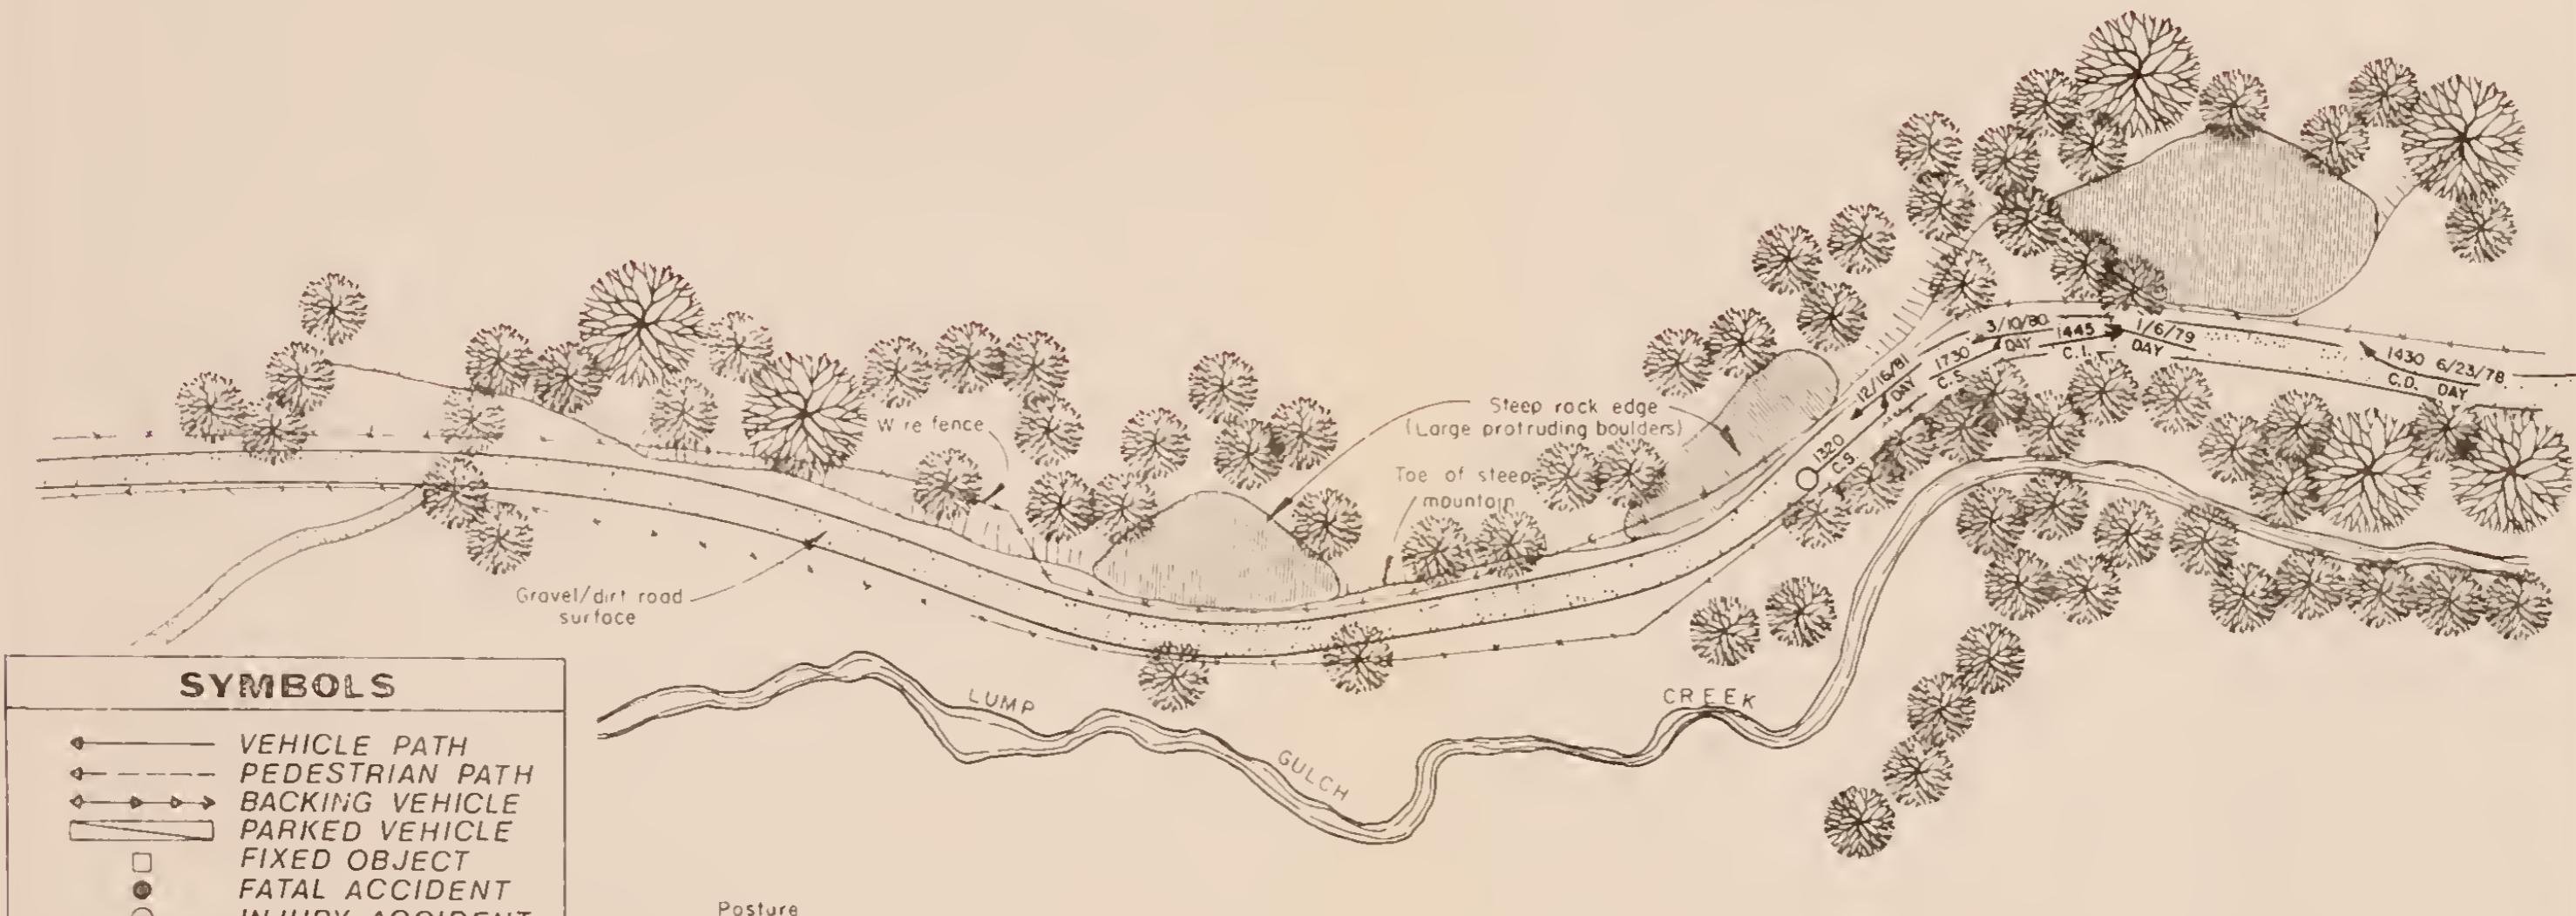
Figure No.
5-C
Jefferson Co.

snowy or icy road conditions, and excessive speed for road conditions. Alcohol was not a factor in any accident at this site. The composite collision diagram for Site #5 is depicted in Figure 5C.

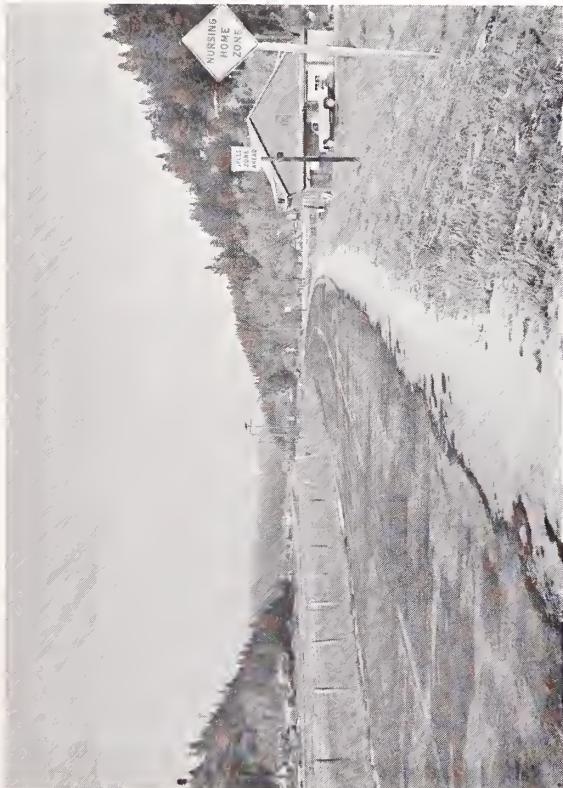
View of the south approach to the intersection. Note the advance warning and the pavement markings.

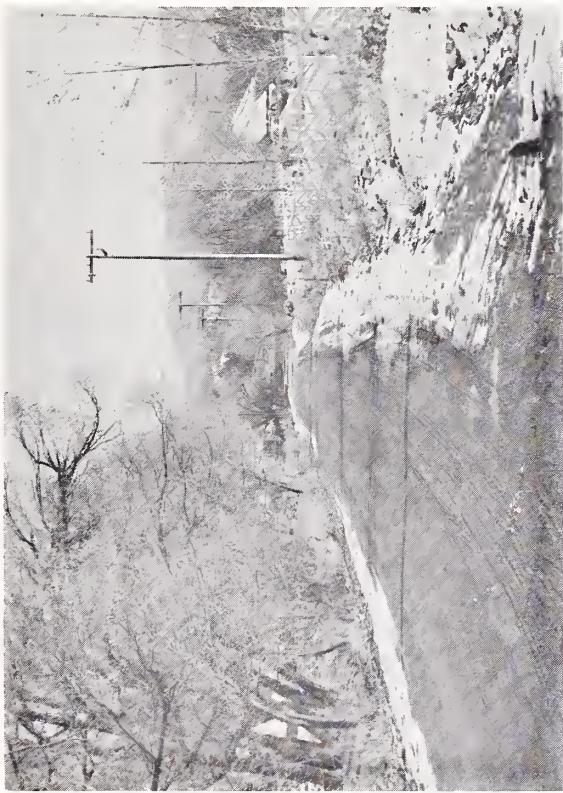
View of east approach to the intersection along Warm Springs Creek Road.

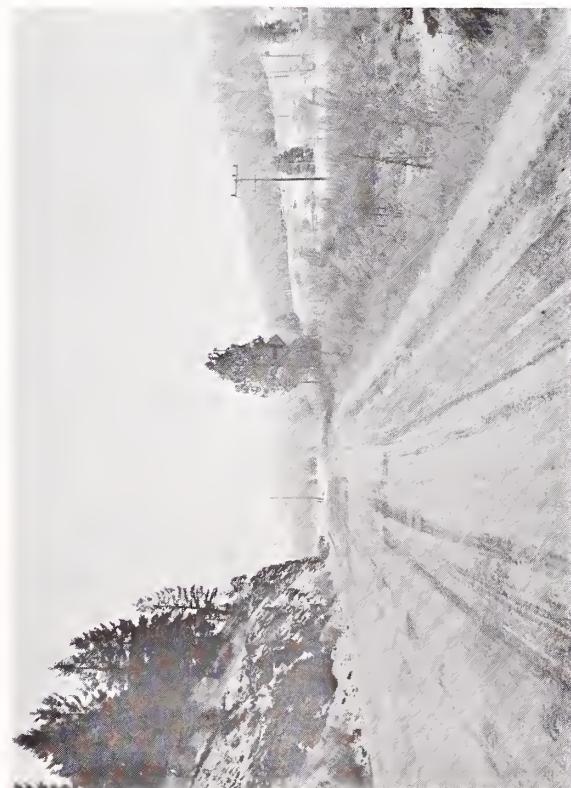
View of the north approach to the intersection. Note the advance intersection warning signs.

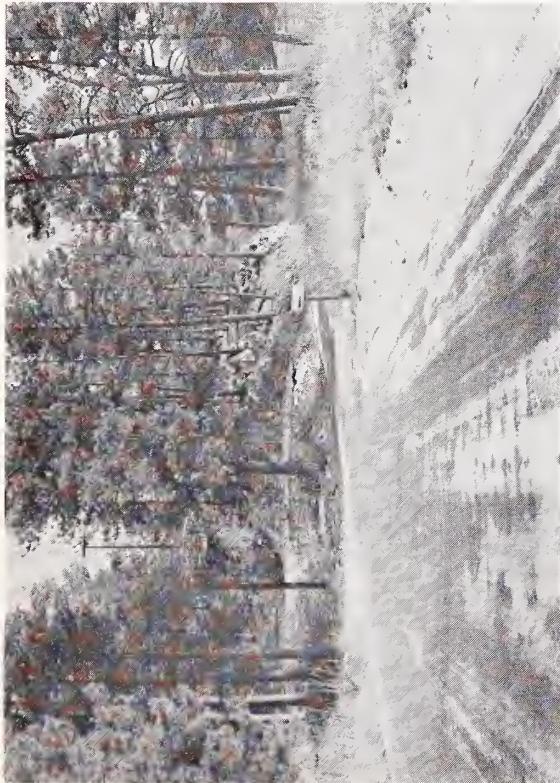
View of the Warm Springs Creek Road near the western edge of Site 7.

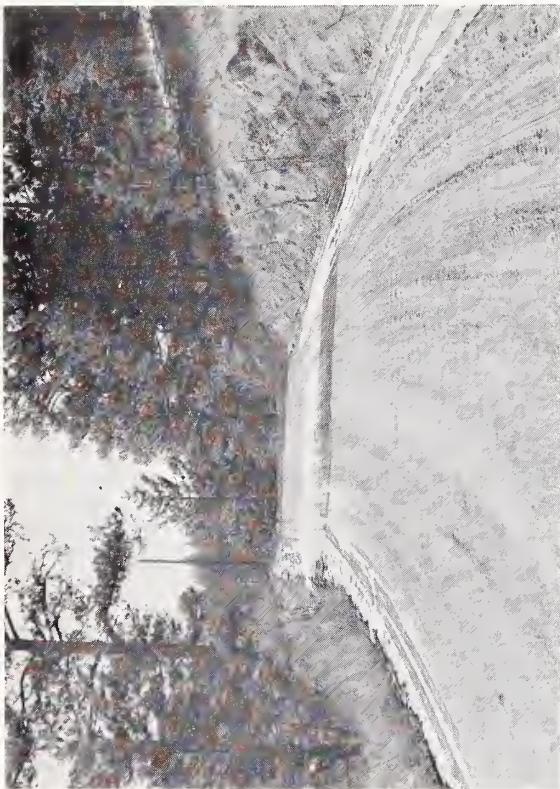
An example of sight distance limitations caused by an abrupt change in road grade. This area is located about midway through the site.

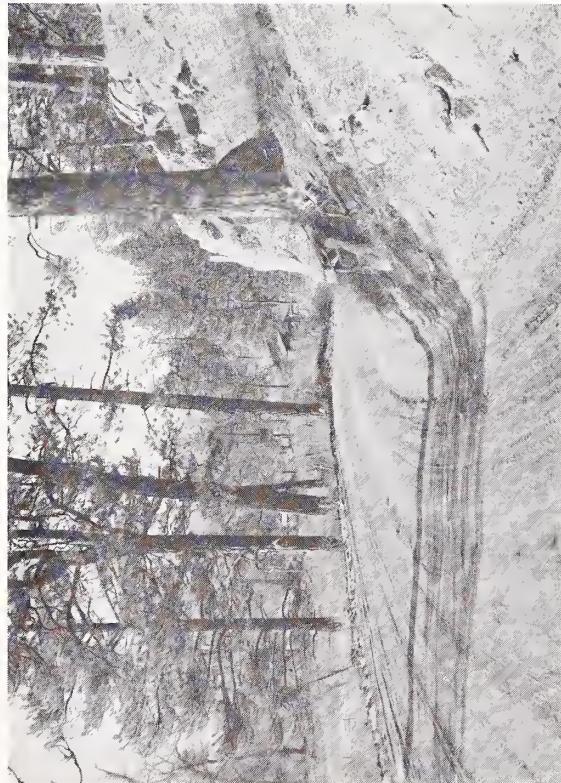
View of the rock outcrop and change in roadway alignment near the western edge of the site that limit sight distance to 110 feet.

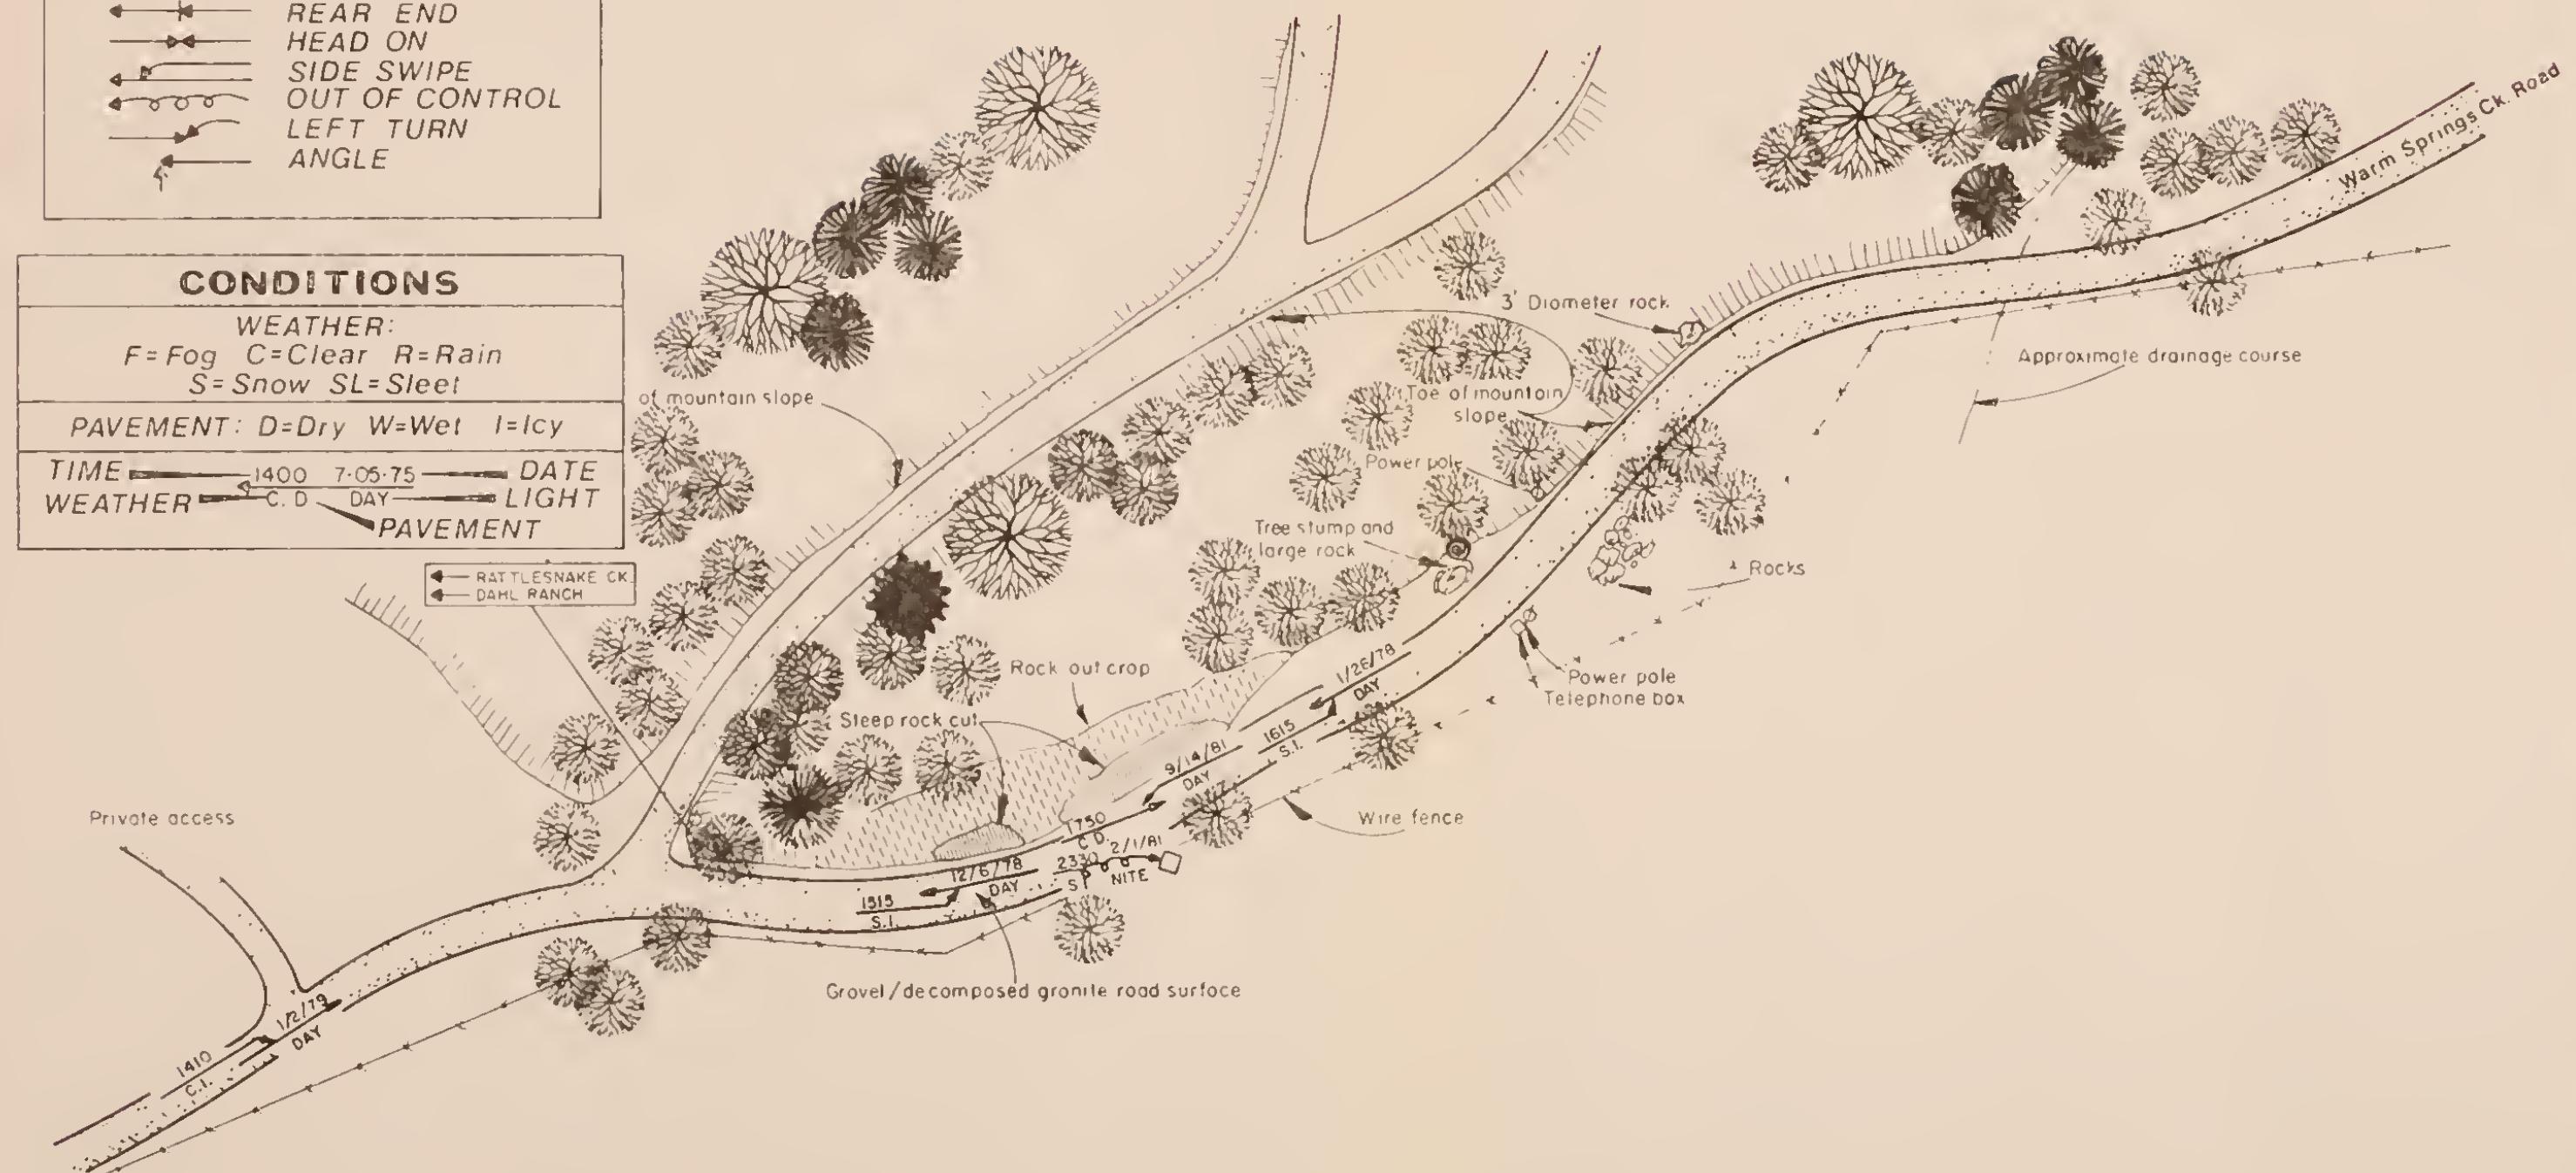
Figure No.
7-C
Jefferson Co.

jects adjacent to the roadway. Four of the five accidents occurred during the winter, and most occurred during daylight hours. Nearly all of the reported accidents occurred during icy road conditions. Due to the surrounding terrain and the thick roadside vegetation along much of this site, built-up snow and ice on the roadway seldom melts off during the day. The major contributing circumstances to the reported accidents at this site appear to be a lack of adequate sight distance and excess speed for road conditions. Alcohol was not involved in any of the reported accidents at the site. The composite collision diagram for Site #7 is depicted in Figure 7C.

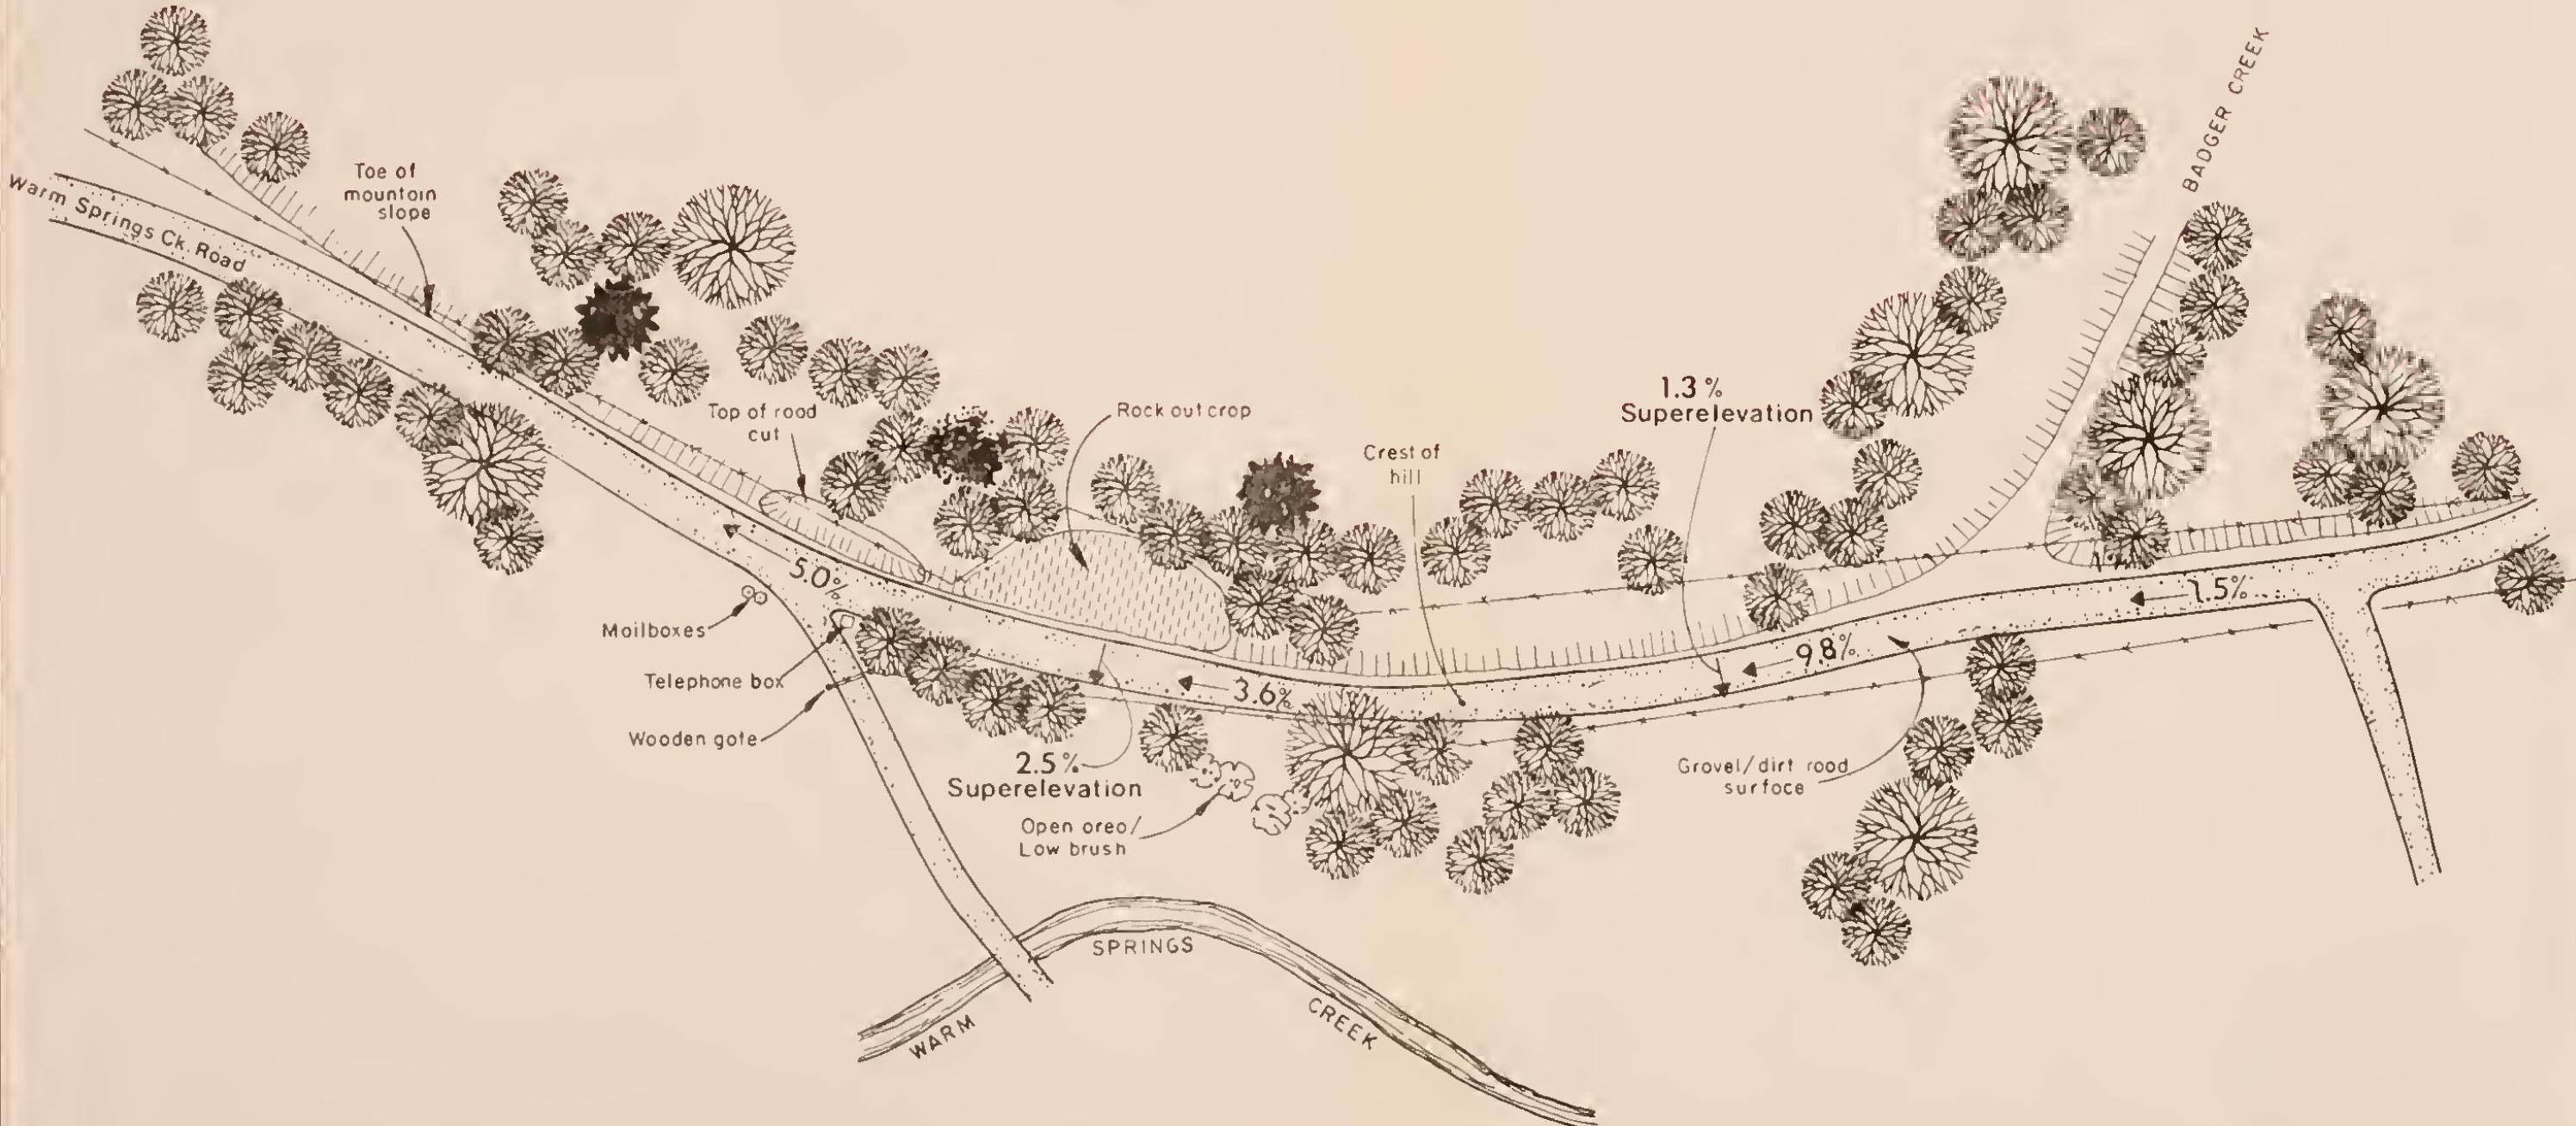
Site No. 8

Warm Springs Creek Road at Site #8 has a decomposed granite roadway surface that ranges in width from 17 to 20 feet. The roadway surface at this location is in fair condition; however, the roadway has a "washboard" surface in several locations. Road grades within the site range from a minimum of 1.5 percent to a maximum of 9.8 percent. These grades occur at opposite approaches to the same hill, and result in severe sight distance limitations. Improper superelevations compound the problem at this location and present motorists with an extremely dangerous driving situation. Ineffective superelevations, which have a tendency to force vehicles to the outside, occur at several other locations within the broad curve at the site. Sight distance at the abrupt grade change is limited to approximately 120 feet. Roadside obstructions and steep shoulder areas adjacent to the roadway also constitute hazardous driving conditions within the site. A large tree at the edge of the roadway limits the width of the travelway to 17 feet midway through the site. Currently, no signing exists within the section of the Warm Springs Creek Road. Existing site conditions are depicted in the site sketch (Figure 8B and the site photographs (Plate 8) accompanying this analysis.

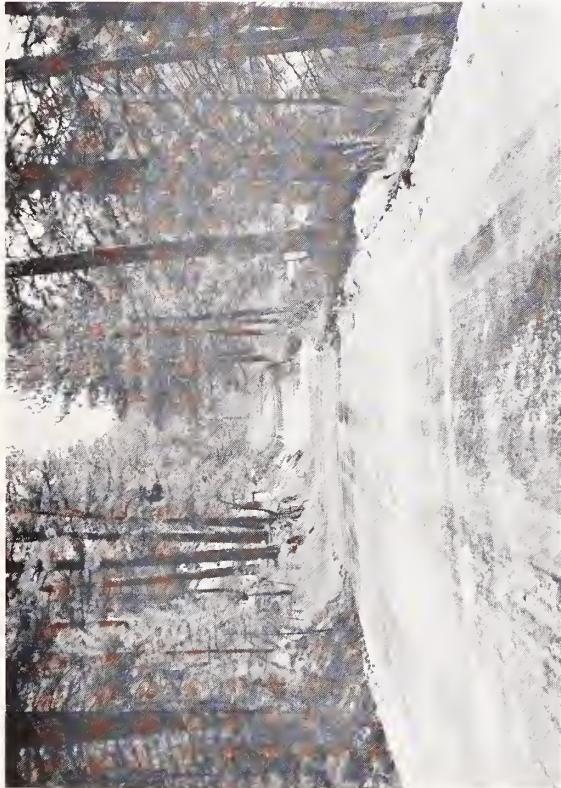
View of the western approach to Site 8. Note the heavy roadside vegetation and the steep areas adjacent to the roadway.

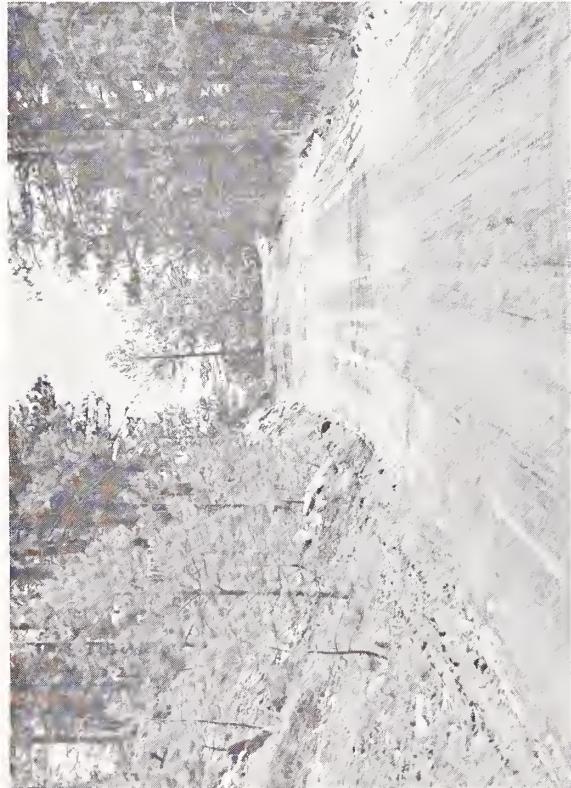
View of the western approach to the abrupt grade change midway through the site. The grade is approximately 9.8 percent at this location.

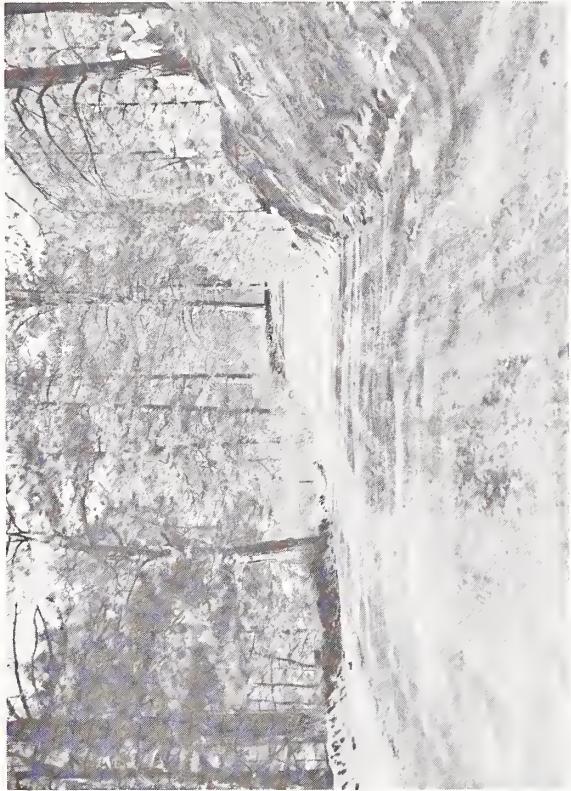
View of terrain typical to this section of the Warm Springs Creek Road.

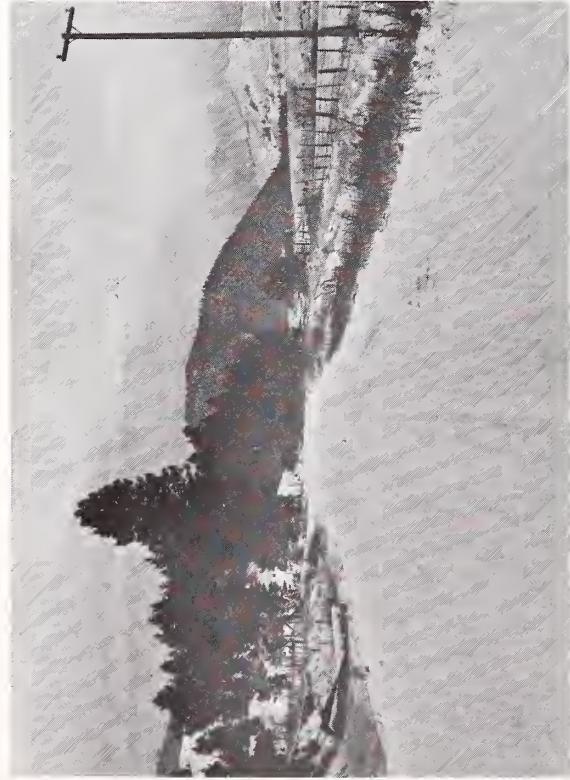
Westward view along the Corbin - Wicke's Road. Note the steep areas adjacent to the right side of the roadway.

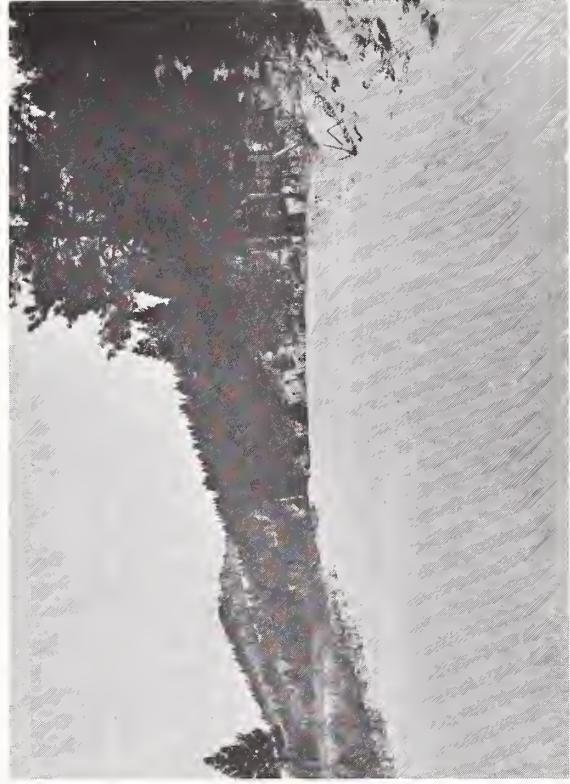
View of an area of restricted sight distance near the western edge of the site. Grade and alignment changes at this location limit sight distance to 150 feet.
